# Oman Transport Safety Bureau (OTSB)

## Final Report

### Tyre Failure and Loss of Hydraulics Oman Air Aircraft Boeing 737-8 MAX - A4O-ML at Muscat International Airport (OOMS), Sultanate of Oman.

**OTSB Case File No: AIFN-003/05/2025**

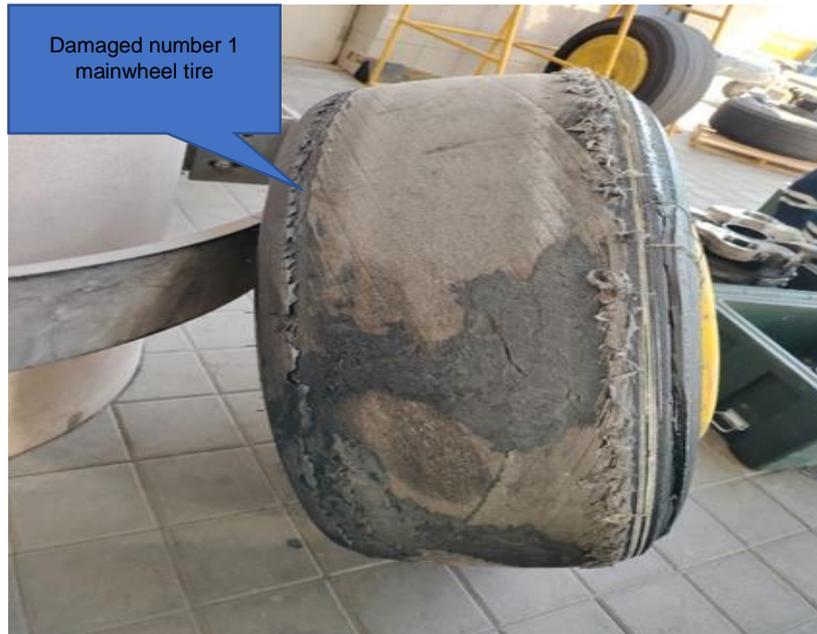
1.3.1 Damages were sustained on the number 1 main wheel tire, brake assemblies of main wheel number 1 and 2, access panels, left hand kruger flap number 2, left hand inboard aft flap, left hand inboard main flap, panels, left hand landing gear lower inner door, inboard pushrod assembly and hydraulic tubes, tube assembly-LDG Up, pulley, bracket assembly holding cable pulley, bracket holding cable pulley refer to the figure 2 & 3 below. After the landing, the Aircraft was inspected, and it was found that the No. 1 main wheel tire (left outboard tire) tread had completely peeled (decapped) off the tire. However, the tire was still inflated and had a tire pressure of 201 Pound-force Per Square Inch (PSI) after the serious incident.

Figure 2 showing damages on the number 1 main wheel tire.

- 1.1.49 Both the left-hand main tire and the brakes for wheels No.1 and No.2 were replaced and the aircraft was towed to the hanger for further inspection.

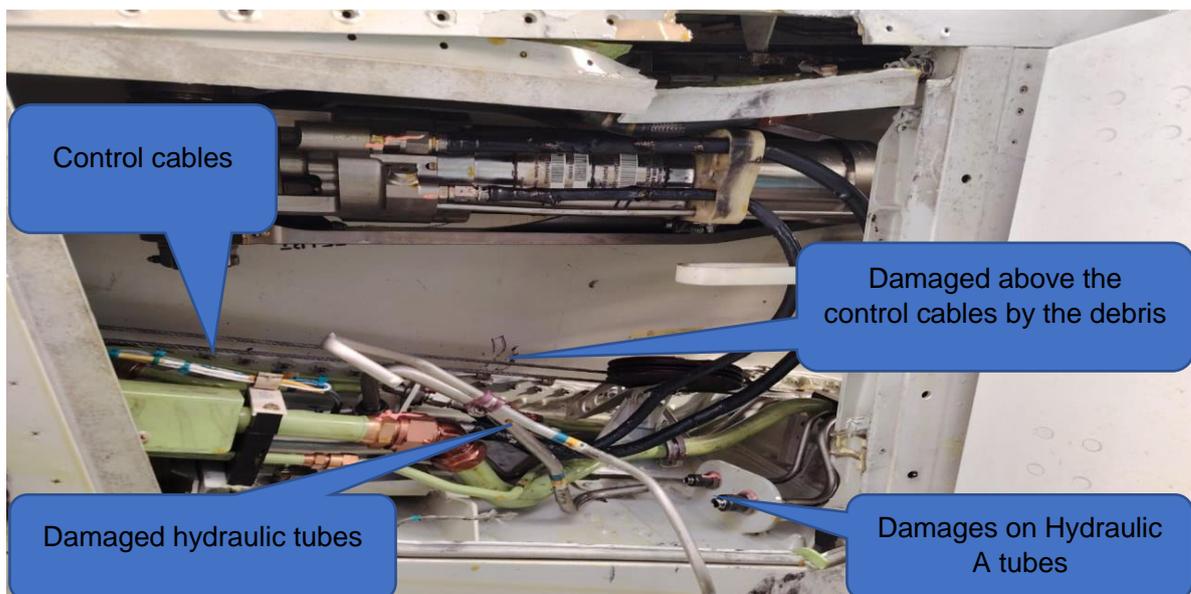
Figure 3 shows the damages on hydraulic tubes.

1.3.2 The Aircraft sustained damages to the hydraulic A tubes inside the top left main wheel panel, and minor damage to shroud above the flight control cables.

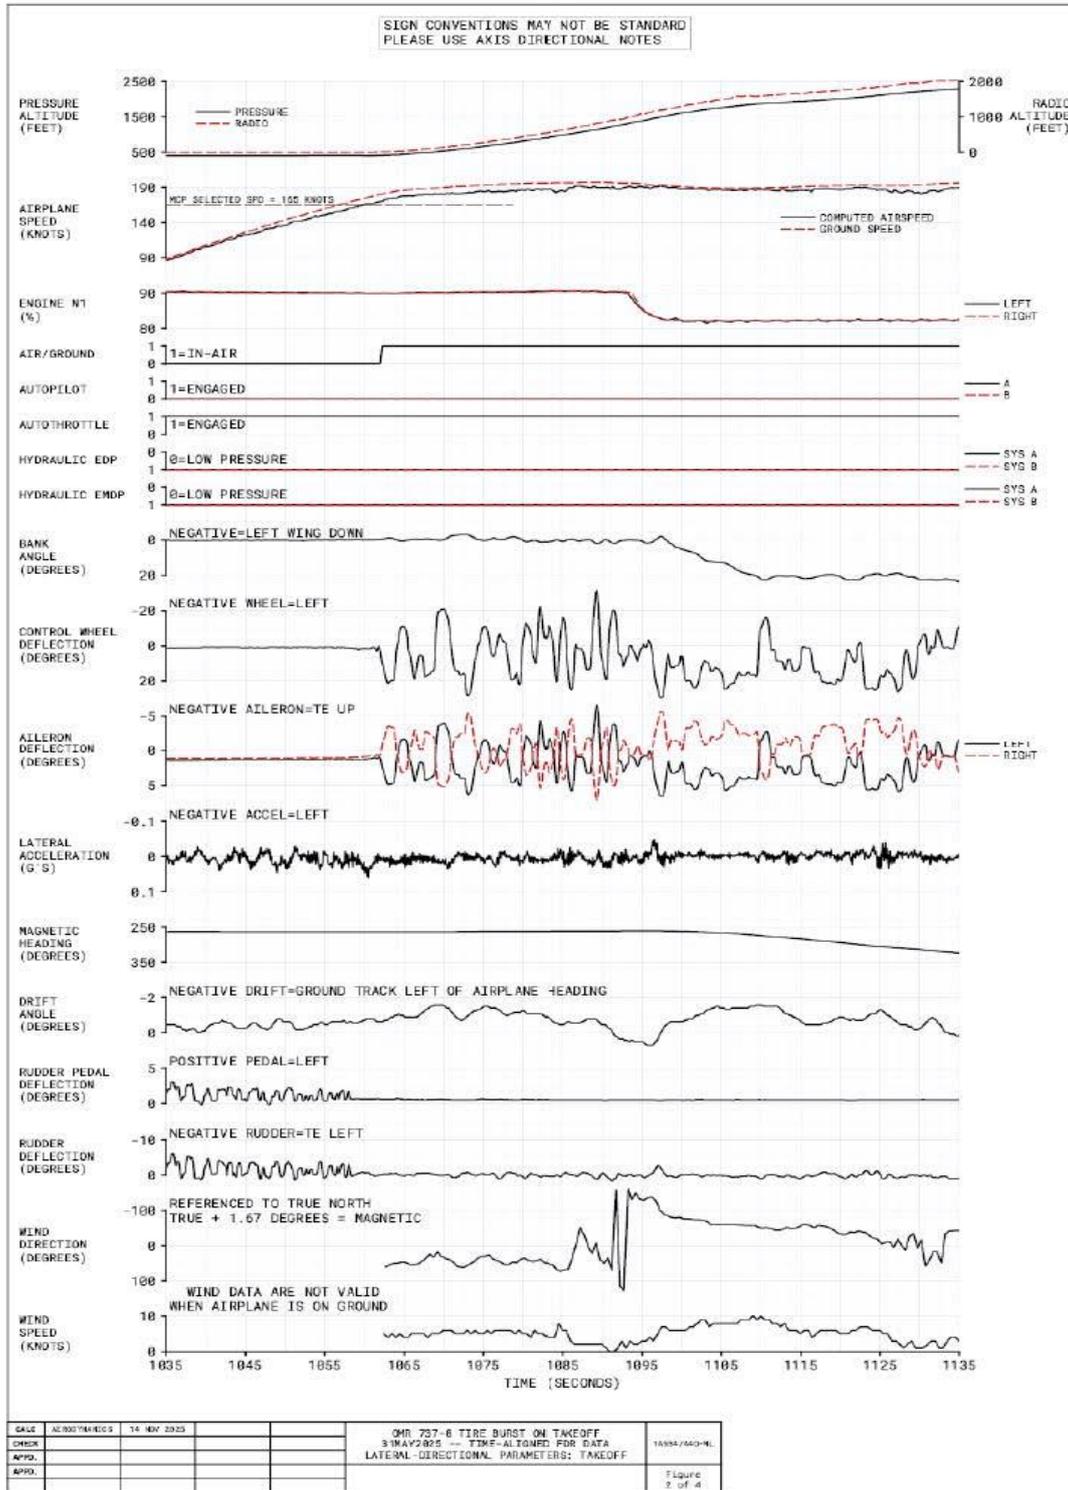
1.11.2 The QAR data analysis shows the aircraft OMA815 beginning its Flaps 1 takeoff roll on MCT RWY 26L. At approximately time 1058 seconds, the hydraulic system A fluid quantity parameter began to gradually decrease. The data indicates that lift off occurred at approximately time 1062 seconds. Just after lift off, at approximately time 1065 seconds, the landing gear lever was moved to UP; at approximately time 1073 seconds, the recorded landing gear data indicate that the left main gear did not transition consistent with the right main gear and nose gear, possibly indicating that the left main gear failed to fully retract.

Figure 5 showing parameters on take-off (Source: Boeing)

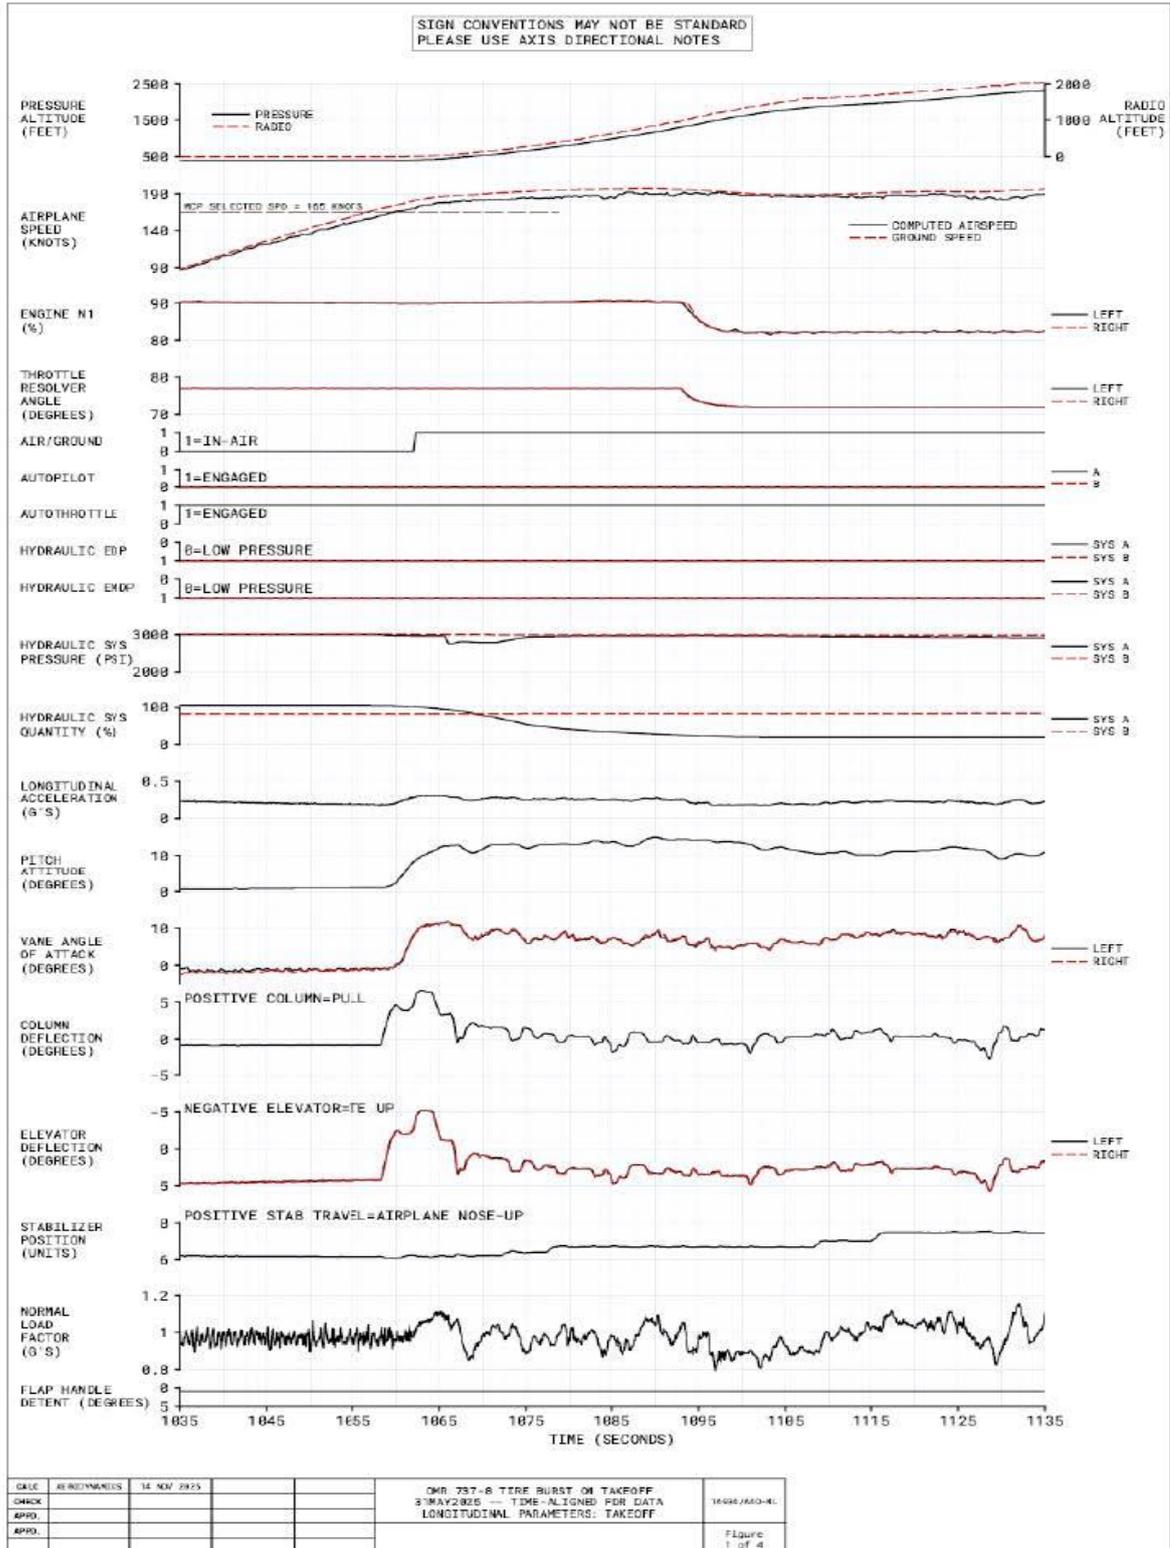
Figure 6 showing Hydraulic System A Pressure dropping (Source: Boeing)

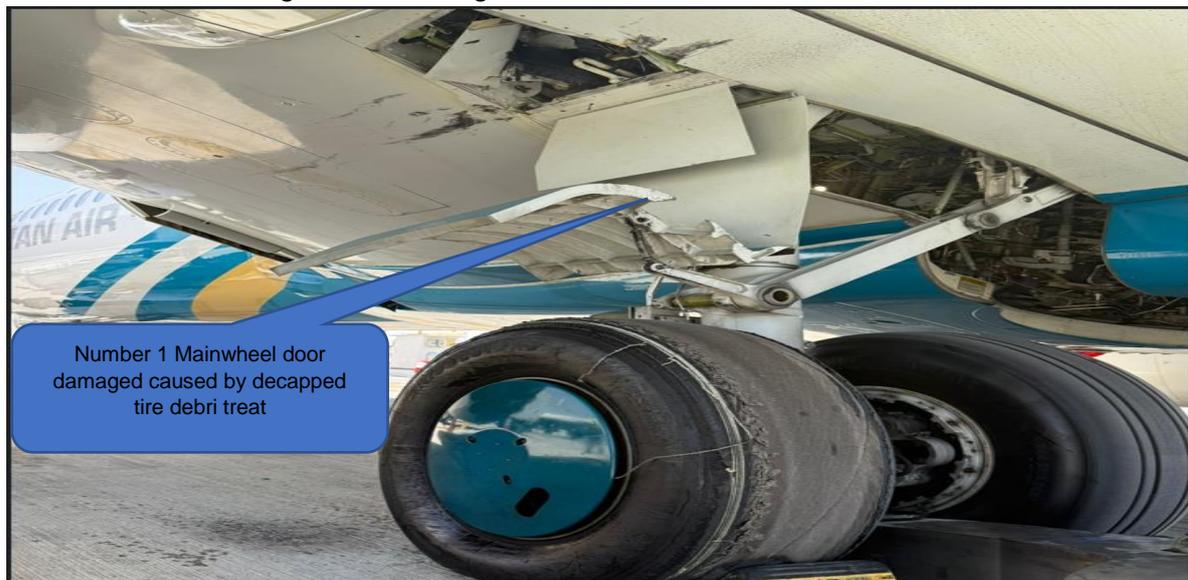
Figure 7: showing Number 1 Mainwheel door damages at the parking bay after landing back.

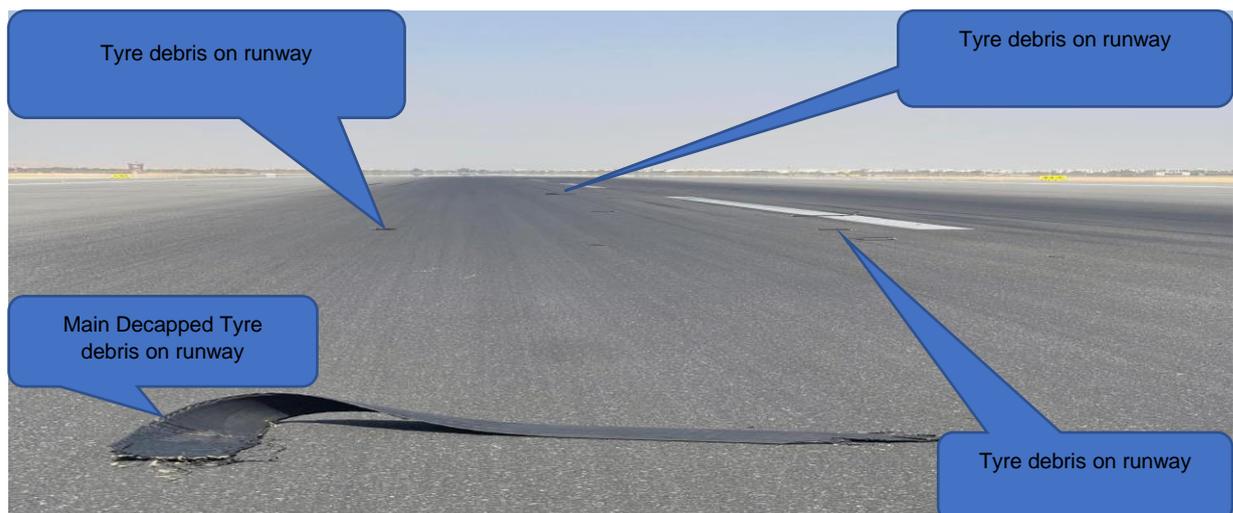
Figure 8: showing evidence of Main Wheel tire number 1 de-capped threat from the tire (Source: Oman Airports).

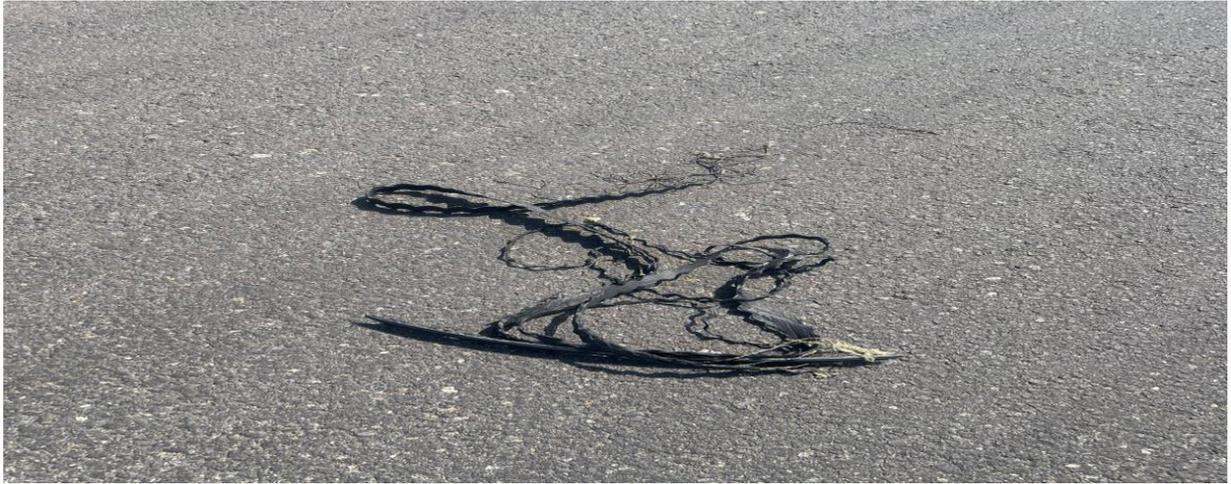
Figure 9: showing evidence of Main Wheel tire debris after tire de-capping (Source: Oman Airports).

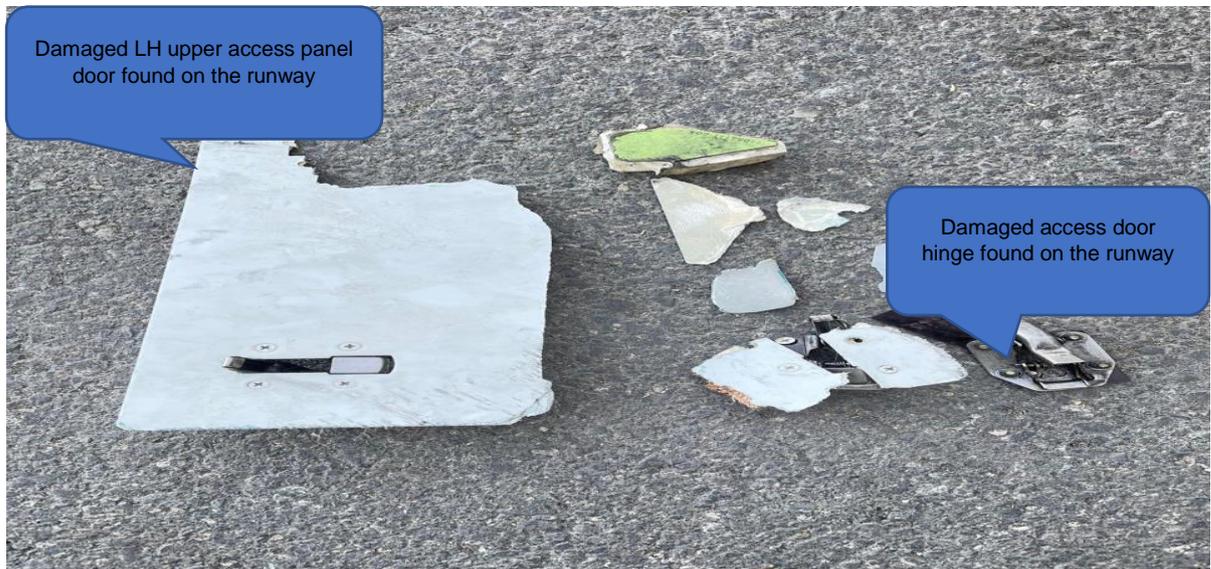
Figure 10: showing evidence of damaged access panel and its hinges above left hand (LH) (Source: Oman Airports).

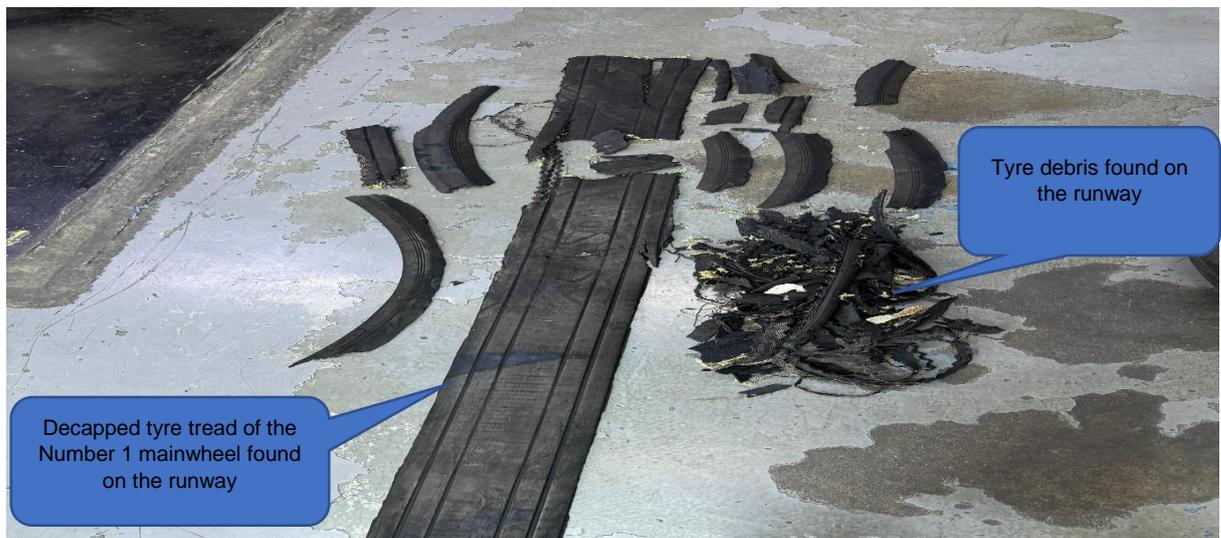
Figure 11: showing evidence of debris found on the runway during the inspection (LH) (Source: Oman Airports).

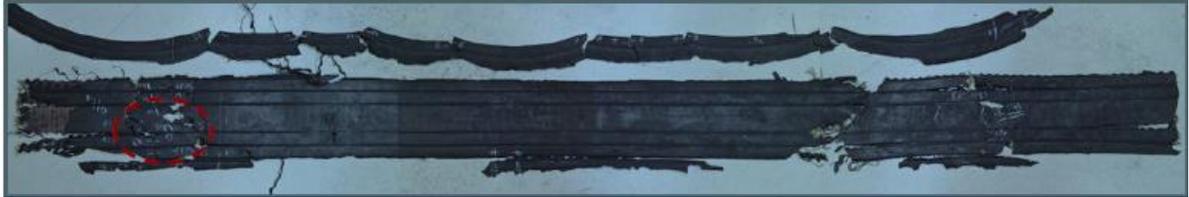
- The separation surface is mainly at the top casing ply surface, and not at the tire recapping surface.
- The Inboard shoulder is still firmly attached to the casing.
- There was no sign of any pre-existing separation or bulge in the casing prior to the tread detachment.

Figure 12 shows the reconstruction of the recovered the tread debris (Source: Bridgestone).

1.16.1.8.2.2 **Examination Results:** Following the thorough inspection performed on the failed tire, the manufacturer concluded that the incident has been caused by an impact from a blunt FOD at a point in the centre crown area. The investigation highlighted that there was no retreading quality issue, casing fatigue in the crown, no sign of any internal separation before the tread separation nor any other manufacturing deficiency in the tire. The evidence suggests that an impact caused a sudden detachment of tread pieces in a small area, followed by the detachment of the remaining tread in one huge piece. This tire failure is considered as operational related.

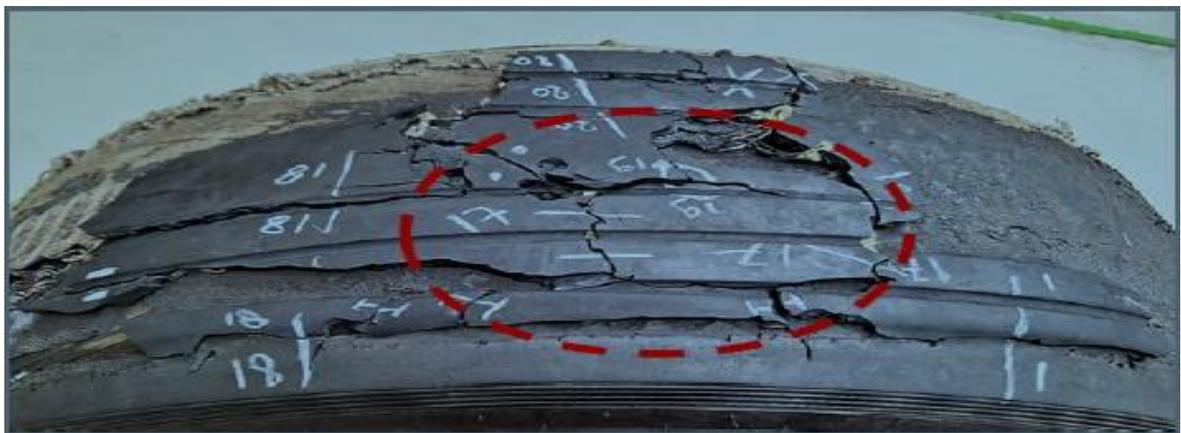
- Nearly all tread pieces were recovered. At one point on the crown surface numerous small pieces detached from the casing, followed by the detachment of one huge piece. It is probable that the area of the small tread pieces was the starting point for the tread separation.
- There are some signs of rubber compression on the multiple tread debris, possibly due to an impact with a blunt object.
- Beneath the area of the small tread pieces some large separation striations are highlighted, indicating the direction of the sudden tread detachment from this point.
- Some small pieces are missing at a suspected starting point in the center crown area.

Figure 13 shows signs of rubber compression on the multiple tread debris (Source: Bridgestone).

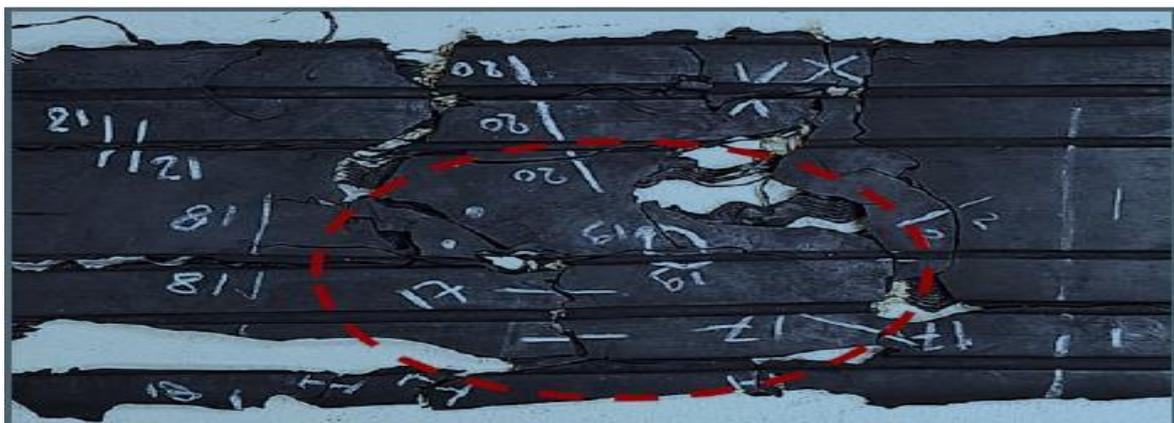
Figure 14 shows the area with multiple detached pieces of tread (Source: Bridgestone).
