# Oman Transport Safety Bureau (OTSB)

## Preliminary Report

### A Rejected Take-off for Air India Express Boeing, B737-800 NG

**OTSB Case File No: AIFN-0002/05/2026**

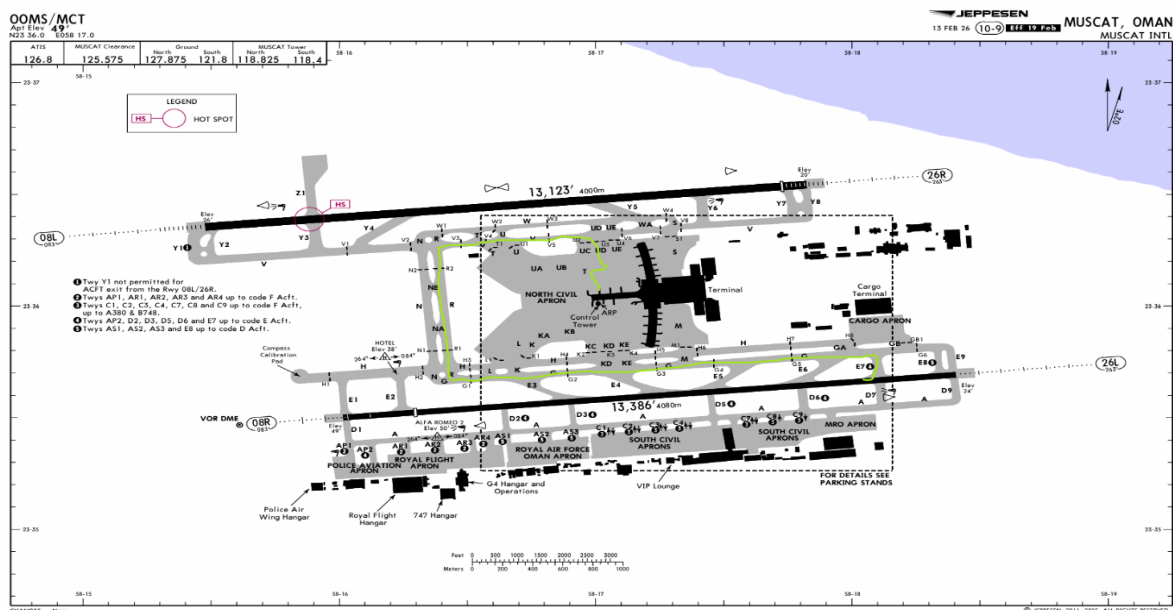
- 1.1.5 At 17:11:53, the flight crew of AXB712 contacted Ground ATCO requesting taxi. The ATCO replied to taxi via TWY Uniform Delta Victor Romeo and to amend the clearance from S08R departure to S26L. The flight crew confirmed in the readback to use departure S26L and to follow the taxi instructions as indicated on the charts of Figure 1.

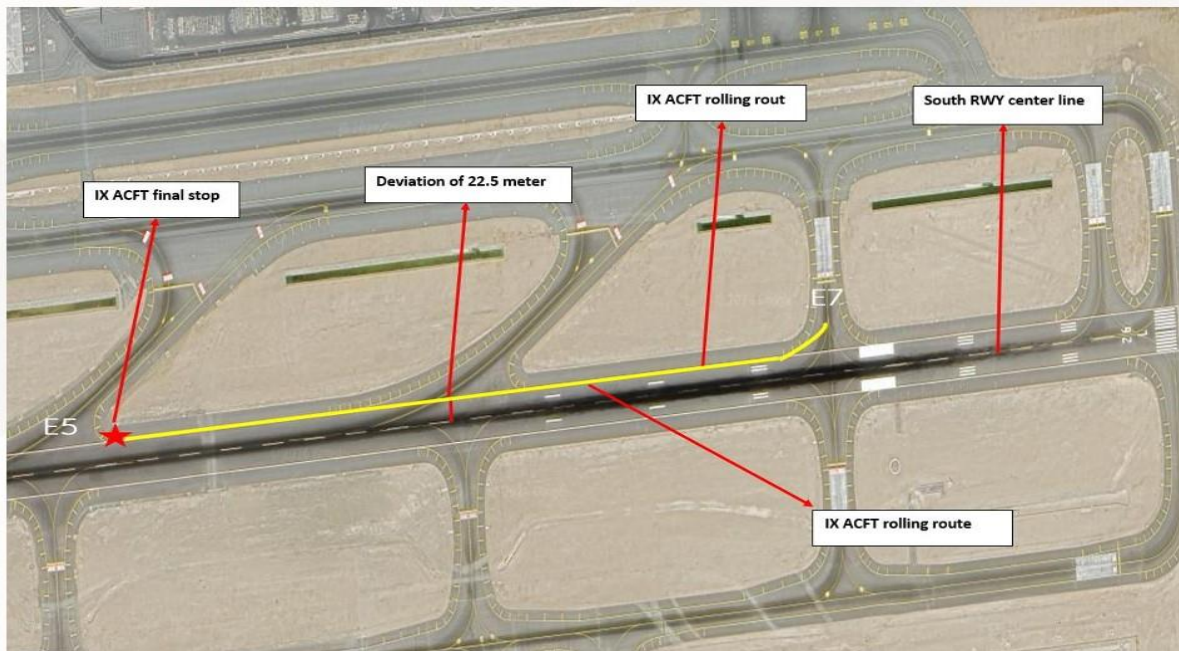
1.1.14 Upon entering RWY 26L for TKOF, the aircraft commenced the TKOF roll while aligned with the RWY edge markings rather than the RWY CL as indicated in Figure 3 below.

Figure 3 showing the layout of OOMS RWY26L and the aircraft TKOF path (Source OA)

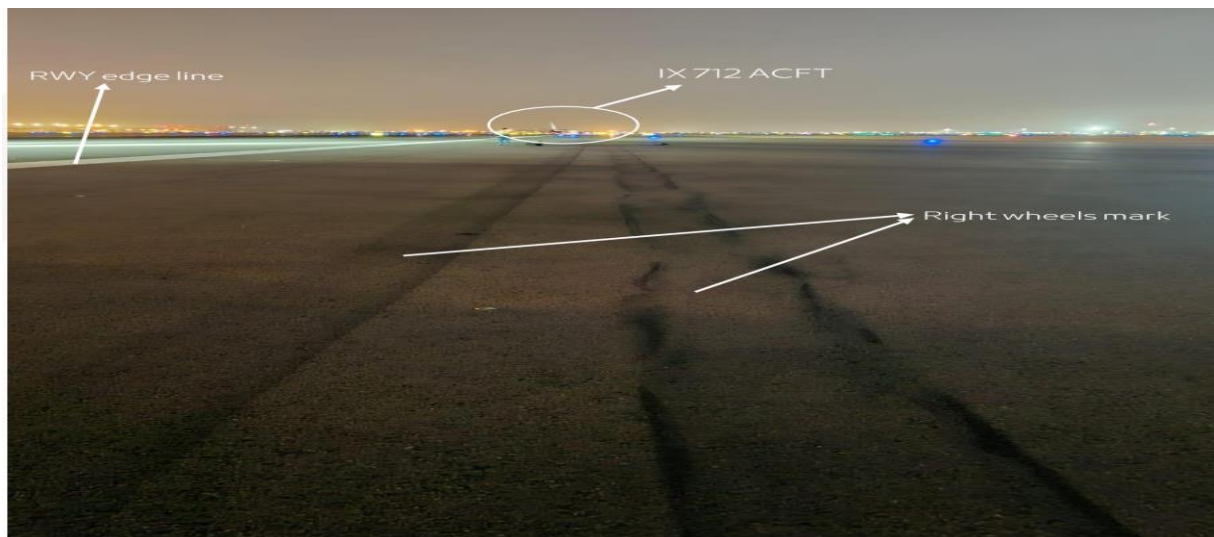
1.1.16 RTO maneuver was carried out by the flight crew of AXB712 after announcing the reject call following the track marks showed in Figure 4 below. As the aircraft commenced TKOF along the RWY shoulder area from TWY E7 up to its final stopping position abeam TWY E5, the aircraft struck some of the runway RWY right edge lights as indicated in Figure 4 below.

Figure 4: shows the tier marks on the right side of RWY26L (Source OA)

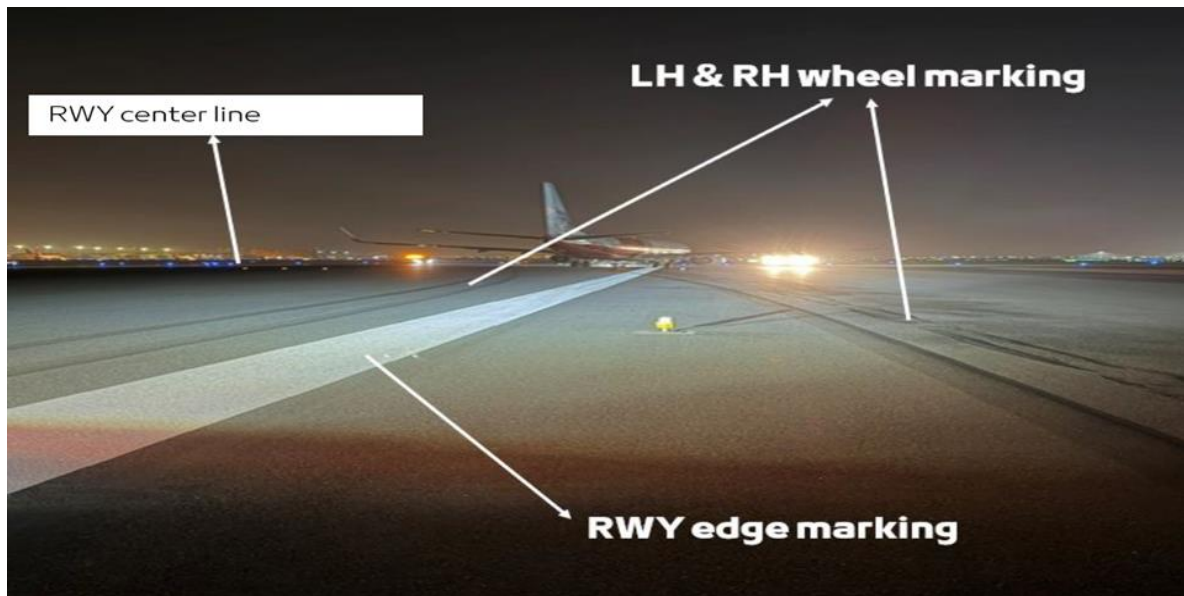
Figure 5 showing the final stop of AXB712 after RTO (Source OA)

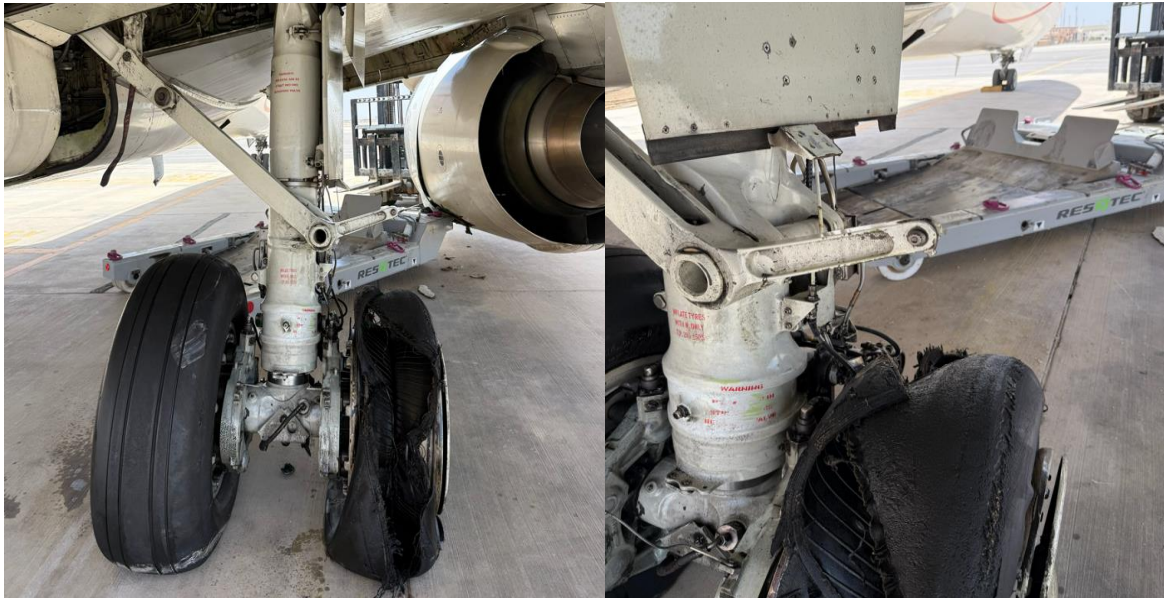
1.3.1 The aircraft sustained damage to the right-side landing gear tires, right nose wheel tyre, both engines, in addition to a hydraulic leak and flap damage as shown in figure 6, 7 and 8 below.

Figure 6 : Shows the main right landing gear tires burst

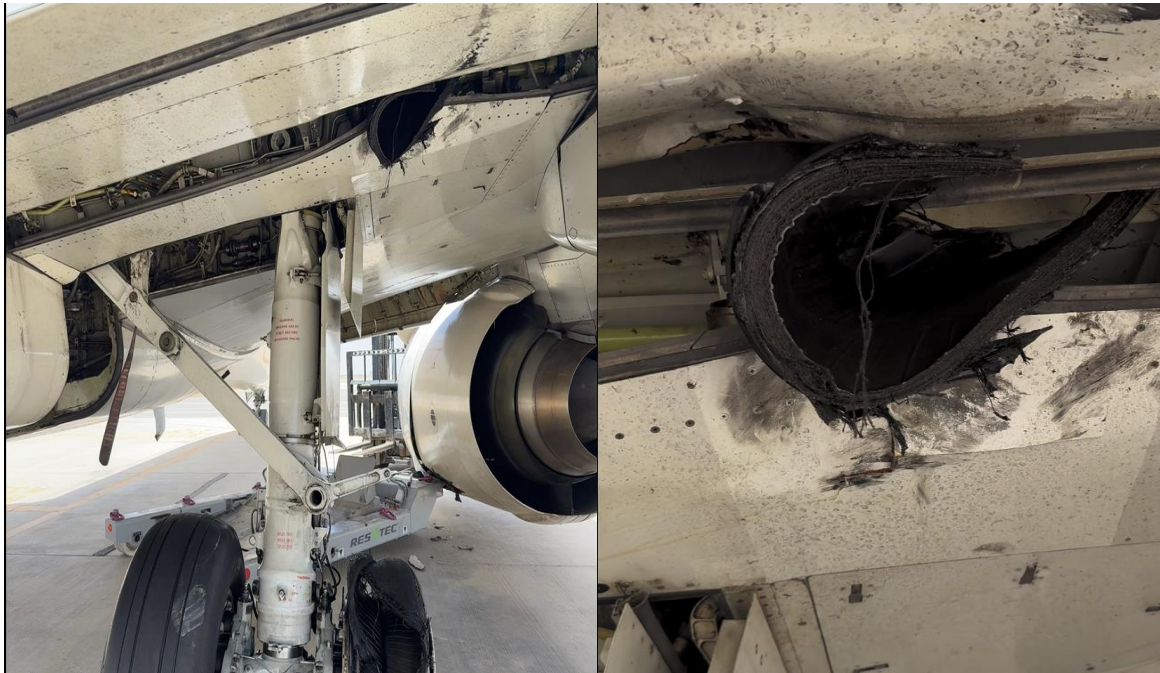
Figure 7: Shows the hydraulic leak due to tire burst and flap damage.

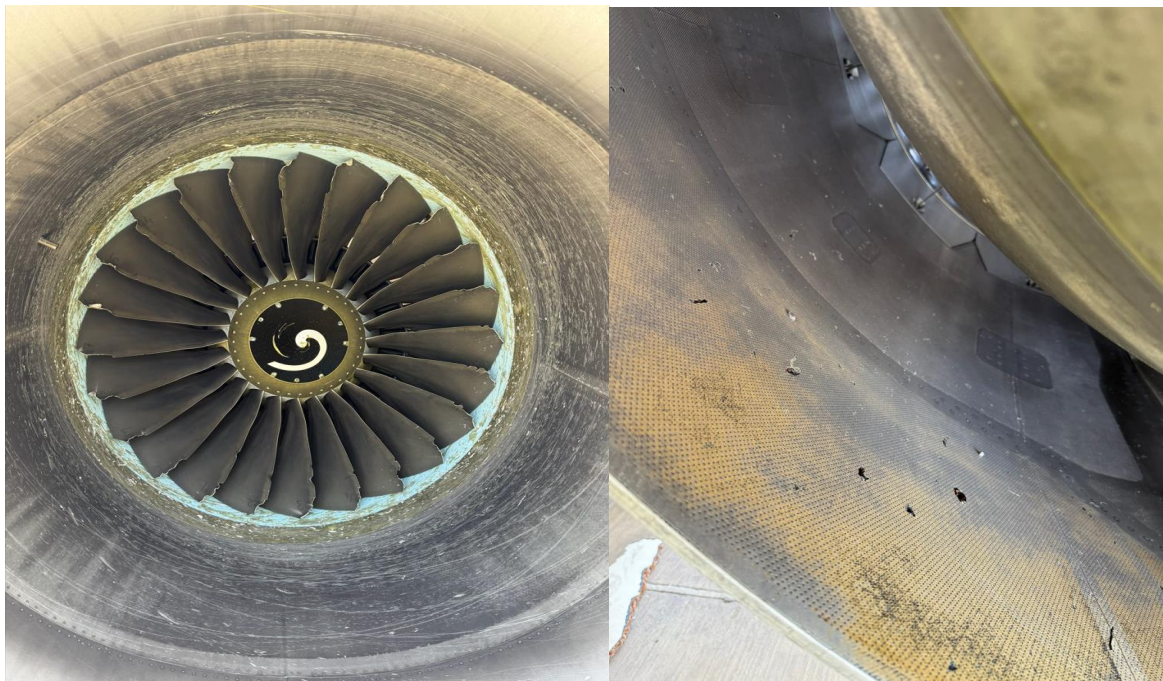
Figure 8: Shows the damage in engine No.2.

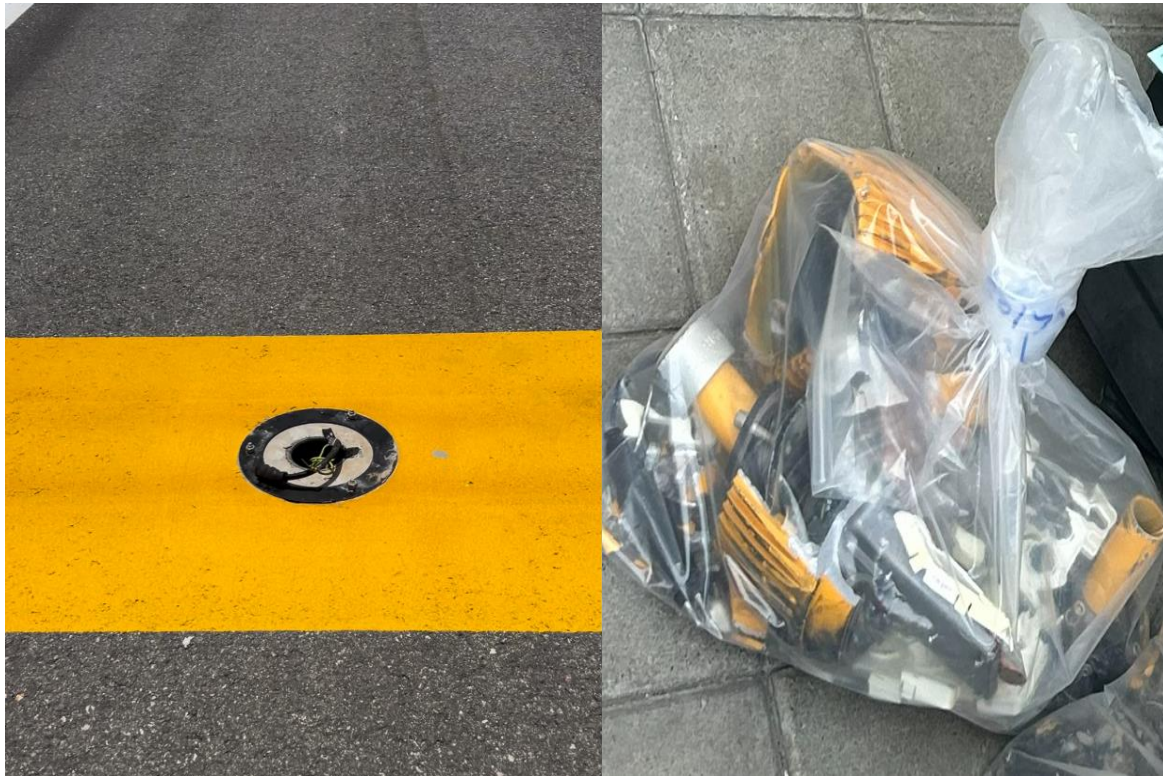
1.4.1 During the occurrence, six RWY edge lights on the right side of RWY 26L were damaged after being struck by the aircraft main wheel tire during the take-off roll as shown in figure 9 below.

Figure 9: Shows the damaged edge lights on the right side of RWY 26L struck by the aircraft wheels.
