Oman Transport Safety Bureau (OTSB)

Final Report

OTSB Case File No: AIFN-005/07/2024

Runway Excursion (RE) at Muscat International Airport (OOMS) on Runway 08L

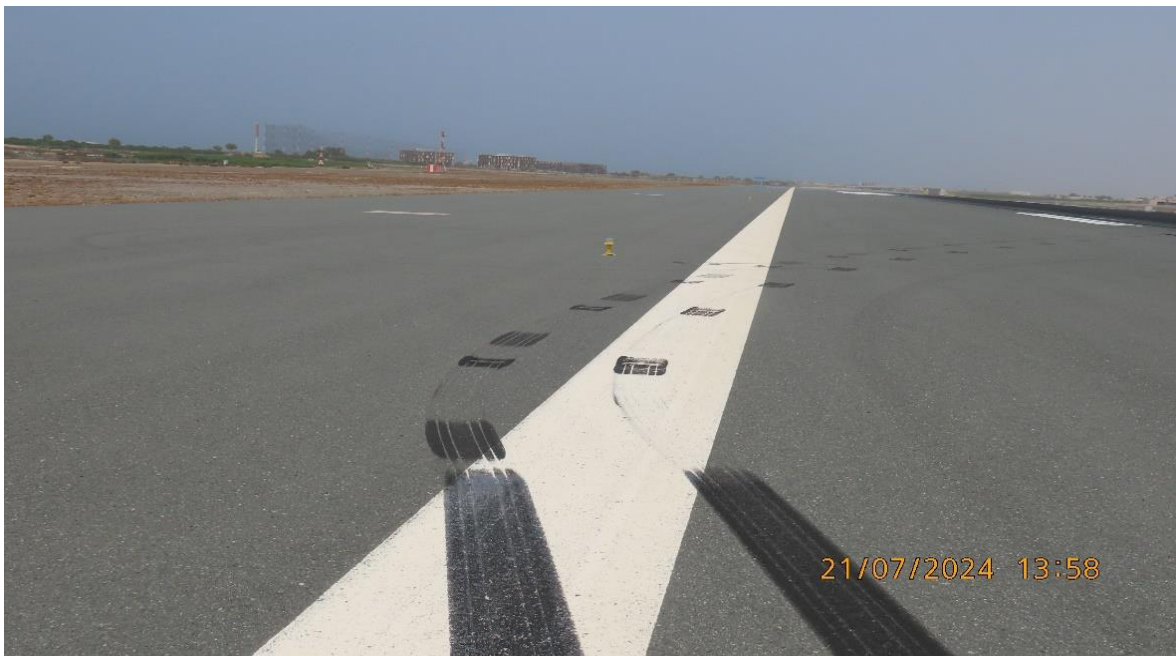
Figure 1: showing evidence of left main wheel tire marks outside the left edge of the RWY 08L.

- 1.1.37 The TWR ATCO requested the OA operations to conduct the RWY inspection. Following the RWY inspections, the OA operations informed the TWR ATCO that aircraft SAW781 had veered one meter off the edge white line marking of the RWY and that one of the landing wheels was damaged. The flight crew never reported exiting the RWY. The TWR ATCO followed up with the flight crew who replied that they lost steering for 5 seconds, causing the aircraft to drift slightly to the left of the RWY centerline. The TWR ATCO further stated that the flight crew of aircraft

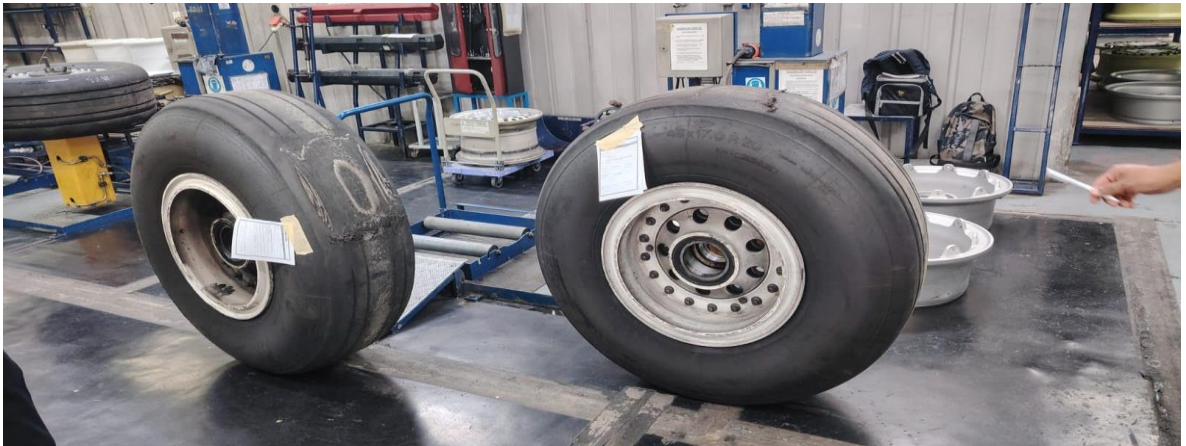
1.3.1. Photos below showing substantial damages on number 1 and 2 main wheels tires.

Figure 2: Showing damages sustained on the right main tires (number 1 and 2).

1.3.2 The airplane underwent flight servicing before flight, which included a tire condition inspection and pressure check. According to the aircraft flight log the wheels, tire condition and tires pressures was normal during the service check. A post-incident visual check and examination revealed that all the damages were as a result of the serious incident.

- 1.1.36 Following the mainwheel tires replacement by the AME, both the LGCIU and NWS were reset and the system check was found satisfactory. The aircraft SAW781 was certified and released to serviceable and flown back to OSDI.

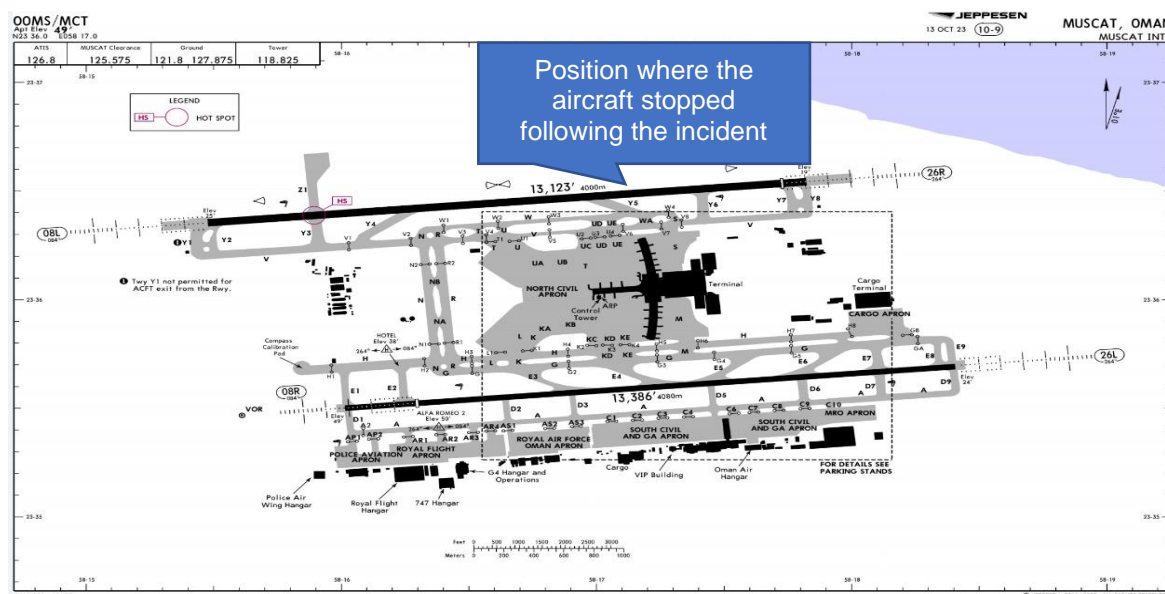
Figure 4: showing OOMS layout and where the incident happened.

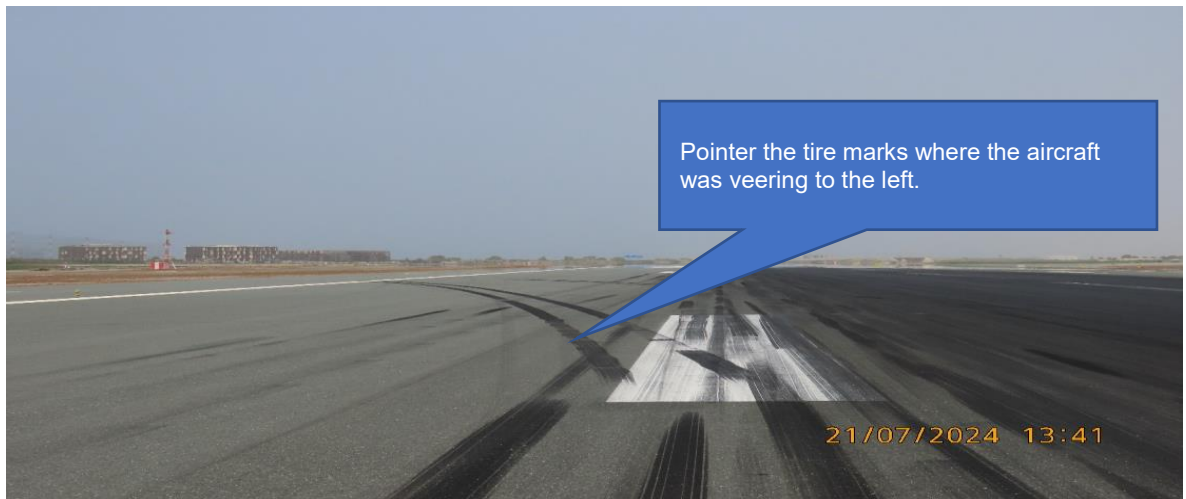
1.12.2 The touchdown was normal with the main wheel however during the nosewheel touchdown the aircraft veered to the left of the RWY.

Figure 5: showing evidence of Left-Hand Main Wheel tire marks veering to the left of RWY 08L.

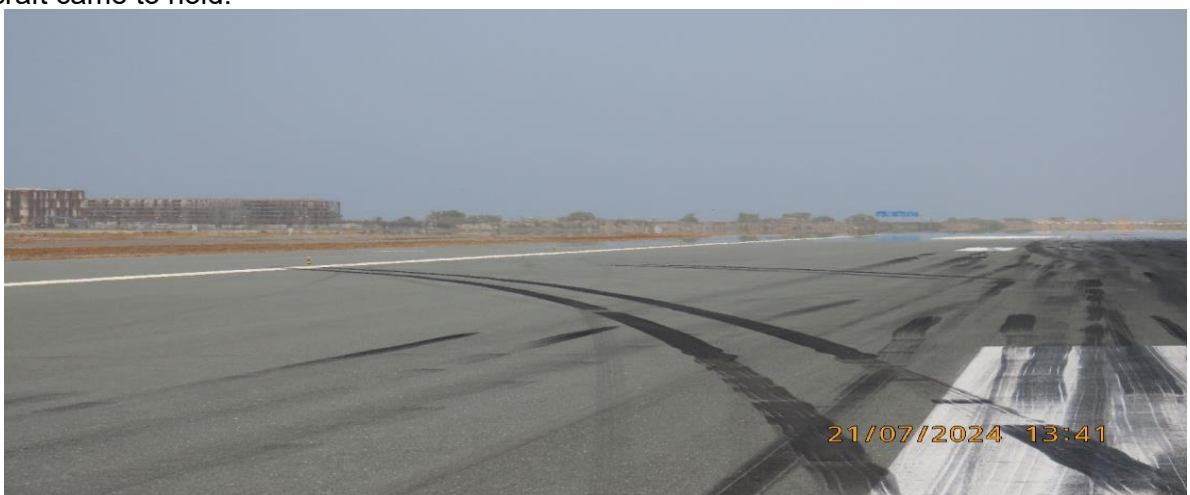
1.12.3 The evidence on the RWY shows brakes was holding and releasing as per the markings on the RWY. This provides evidence that the right-hand brake pedal was applied continuously until the aircraft came to hold.

Figure 6: showing evidence of tire marks turning to the left of RWY 08L.

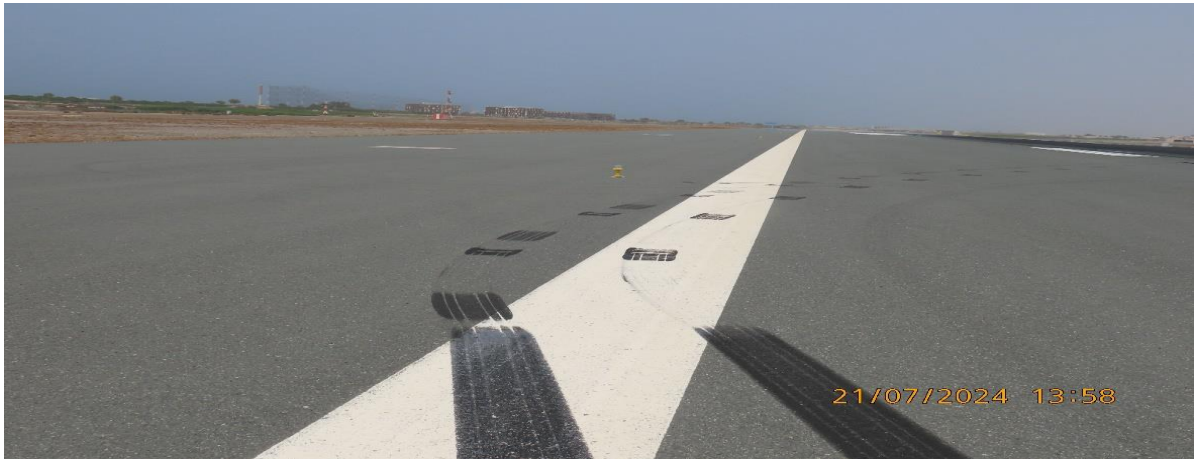
Figure 7: showing evidence of left wheel tire marks showing anti skids jerking outside the left edge of the RWY 08L while turning right into the RWY 08L, towards Taxiway Y6.

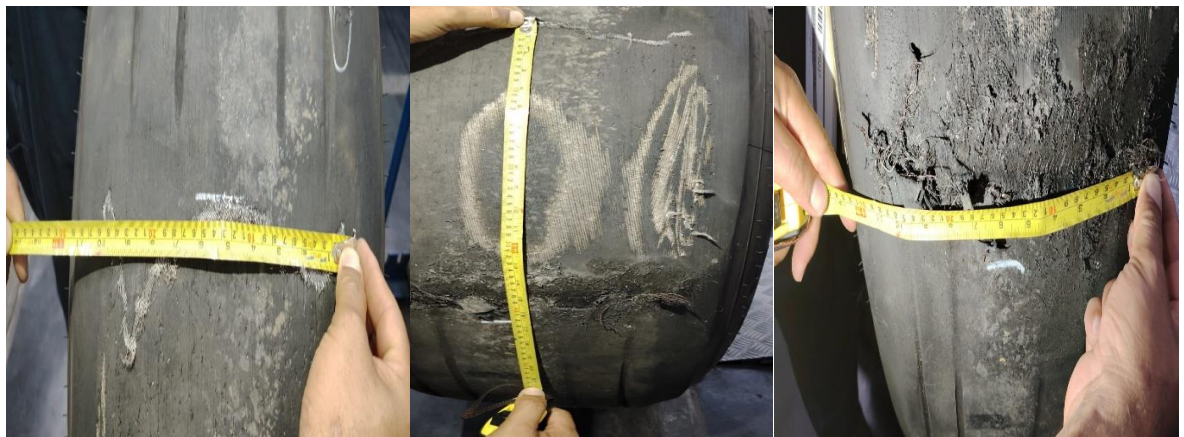
Figure 8: showing evidence close view of the main wheel tire damages.

1.12.4 There was evidence of brake jerking on number 1 and 2 mainwheel tires even after the NWS system was reset by the flight crew. The aircraft proceeded taxiing to the allocated gate through Taxiway Y6 without further incident.
