# Oman Transport Safety Bureau (OTSB)

## Final Report

OTSB Case File No: AIFN-002/05/2025

### Runway Incursion (RI) between Two Oman Aviation Academy (OAA) Aircraft - Diamond DA40 NG A4O-OAI and Diamond DA40 NG A4O-OAG At Sohar (OOSH) International Airport, Sultanate of Oman.

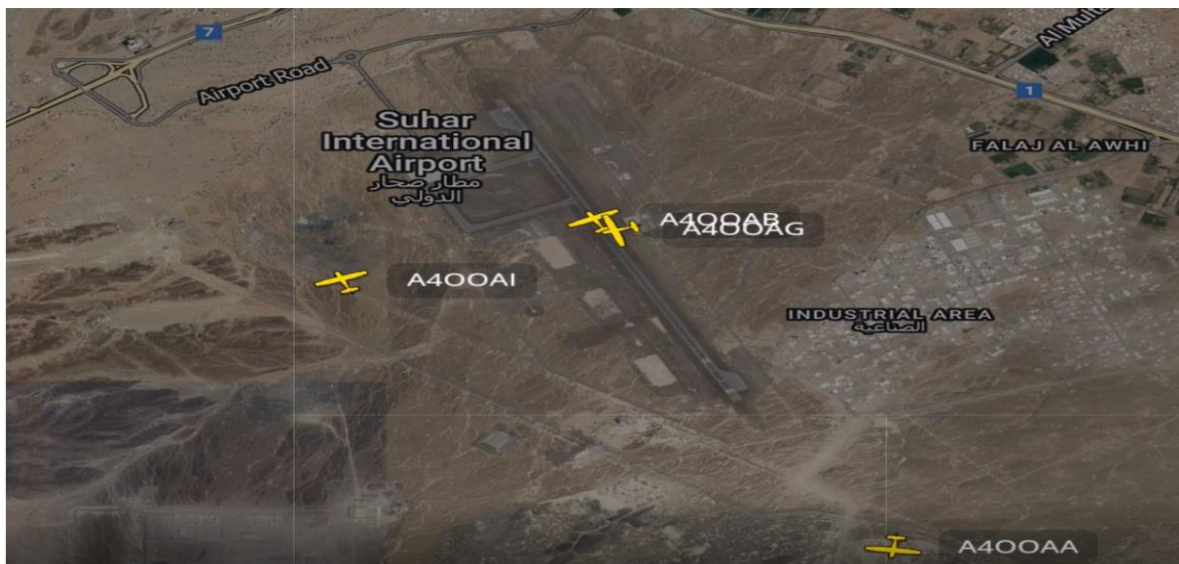
- 1.1.3 A4O-OAI and A4O-OAA were operating in the circuit patterns while A4O-OAG and A4O-OAB were taxiing on the RWY at OOSH aerodrome, maintaining communication with the AFISO and with each other on the AFISO's frequency. According to the operator it was a busy morning, the AFISO was communicating with four aircraft (A4O-OAI, A4O-OAG, A4O-OAA, A4O-OAB) at the time of the serious incident. See figure 1 below.

Figure 1 - Positions of aircraft communicating with AFISO at start of taxi (Source: OAA).

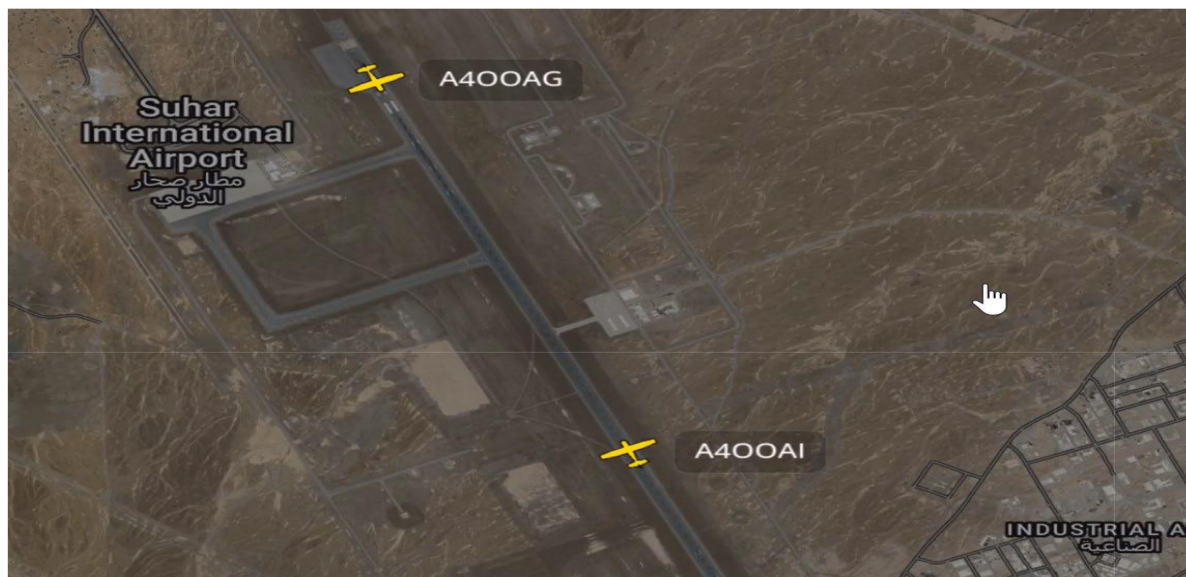
- 1.1.6 The student pilot of aircraft A4O-OAG reaching the threshold of RWY 15, made 180 degrees turn and reported ready for departure and AFISO responded by stating “Take-off at your discretion”. The student pilot of A4O-OAG then began the take-off, unaware that aircraft A4O-OAI after performing TGL, performed EFATO exercise followed by a full stop landing and was still backtracking on Runway 33 to vacate the runway via taxiway Bravo (B) 4.

Figure 2 - Positions of both aircraft when aircraft A4O-OAG started take-off (Source: OAA)

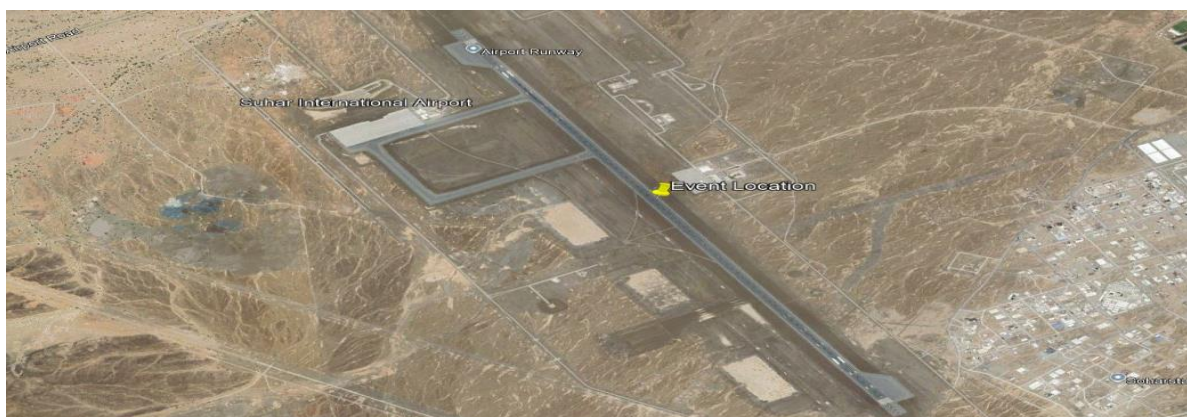
- 1.1.11 According to available records, the student pilot of aircraft A4O-OAG passed behind the aircraft A4O-OAI, which was vacating the runway via taxiway Bravo (B) 4, at an altitude of 600 feet Above Mean Sea Level (AMSL). Fig 3 indicate the point of the occurrence.

Figure 3 - Shows the position where the serious incident happened (Source: Operator).

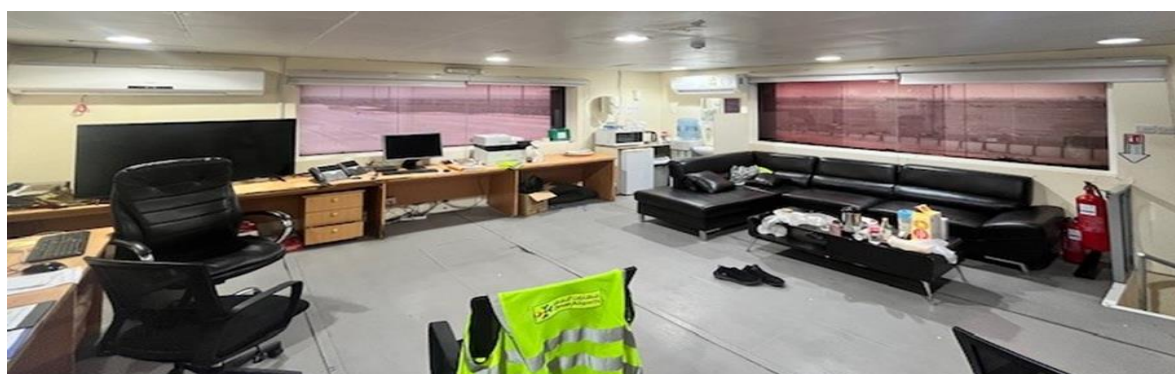
1.10.2 OOSH AFISO is currently utilizing AFIS room which is located within the main terminal building and far from the runway, where the AFISO is having difficulty to observe all the aircraft taking off and landing and also movements on the runways, taxiways and aprons is obstructed as described in Fig 6 and Fig 7.

Figure - 6 showing the current AFISO office lighting and set up and view of the RWY15/33 west and north directions

2.2.7.5 The investigation identified that the AFIS office design, position and surrounding environment as a contributing factor to the serious incident causing runway visibility obstruction for AFISO to be able to see the movements on the runway. This includes issues like inadequate - height, window angle and placement, and nearby obstructions such as buildings, all of which create visual blind spots or restricted views especially during take-off and landing.

4.2.2.1.1 Given the increased traffic density and the limited responsibilities assigned to the AFISO, the OTSB recommends that the CAA review current operations at OOSH to determine whether Tower ATS services should be established at the aerodrome.

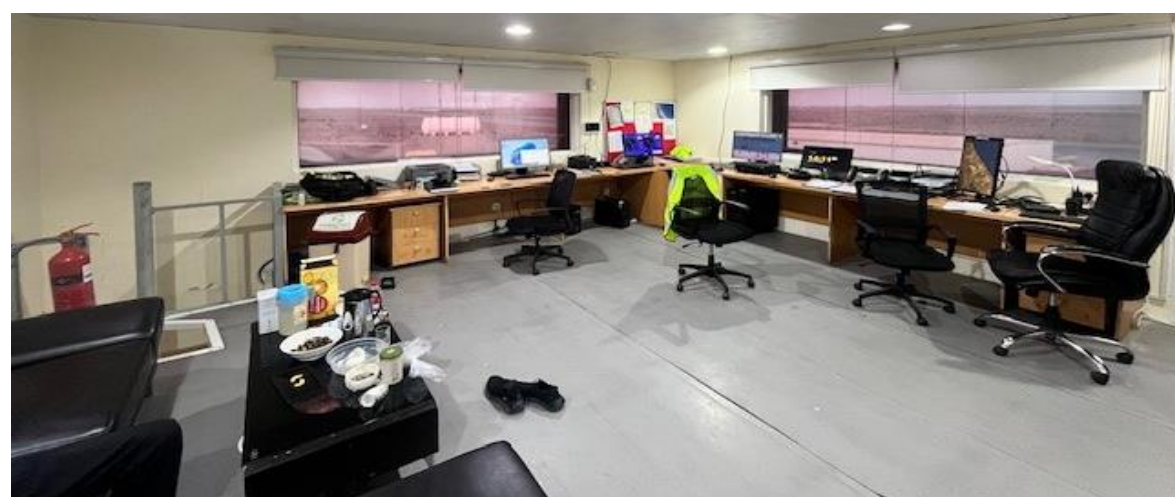
Figure - 7 showing the current AFISO office set up and view of the runway east and south directions of RWY 15/33

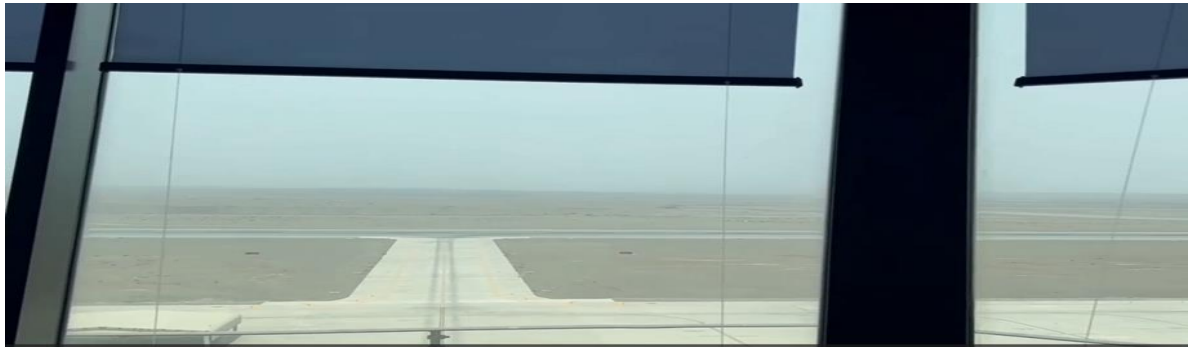
1.10.3 OOSH airport has a tower which is equipped and positioned in the middle of the airport where an air controller would be able to monitor and observe all the traffic taking off and landings and also all of the movements on the runway, taxiways and apron as it shown in Fig 8. This Control Tower environment is equipped with a modern communication equipment and modern visual aids that helps to observe traffic as it shown in fig 9.

Figure - 8 showing the clear view of the runway from the position of Sohar unmanned Control Tower viewing west direction

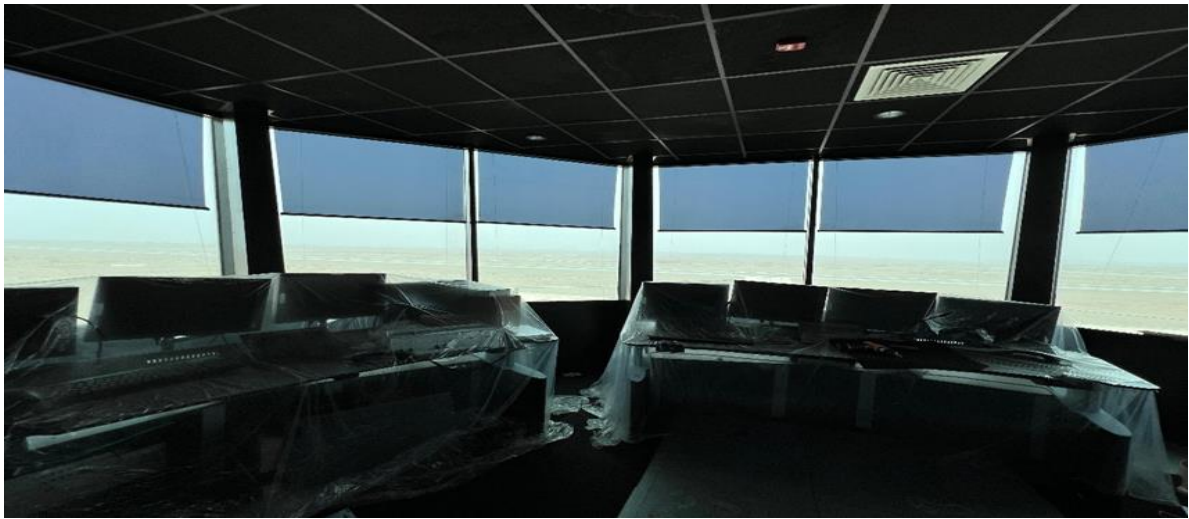
Figure - 9 showing the equipment fitted in the unmanned Control Tower viewing east direction
