# Oman Transport Safety Bureau (OTSB)

## Final Report

### Tyre Failure and Loss of Hydraulics Oman Air Aircraft Boeing 737-8 MAX - A4O-ML at Muscat International Airport (OOMS), Sultanate of Oman.

**OTSB Case File No: AIFN-003/05/2025**

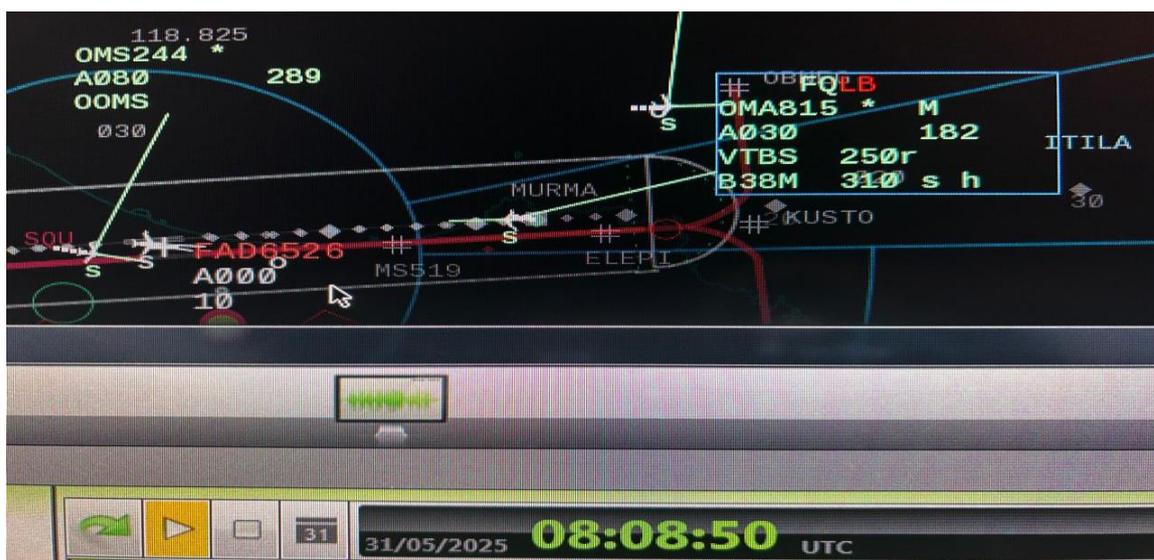
Figure 1 showing aircraft OMA815 at 3000 FT at a speed of 182 KTS cleared to land on RWY 26R

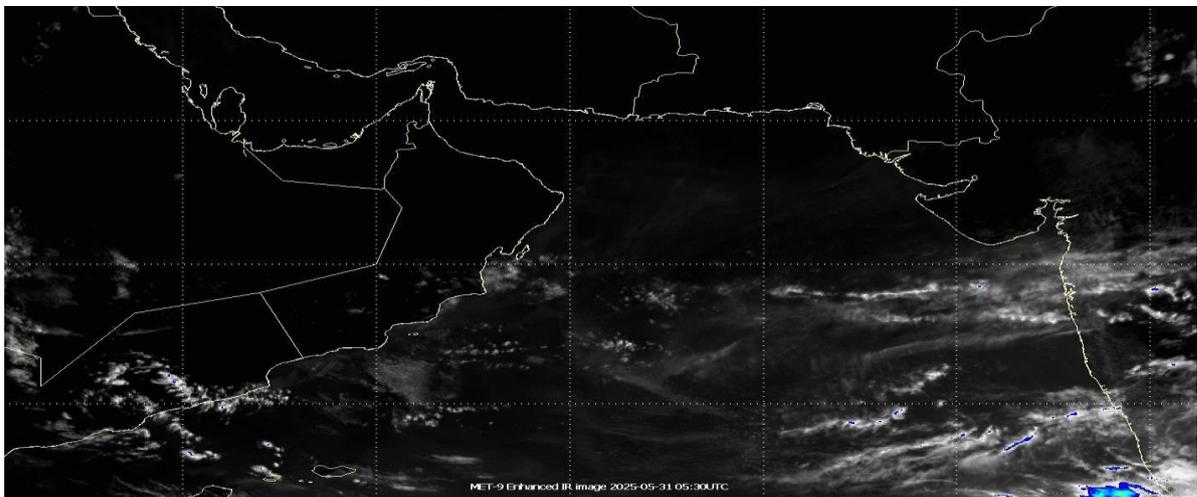
1.7.3 According to Directorate General of Meteorology (DGMET) office, satellite imagery indicates stable weather conditions with clear skies over Muscat FIR. No significant clouds or convection has been observed, therefore no warnings have been issued.

Figure 4 showing satellite image at 05:30Z on 31<sup>st</sup> May 2025 at OOMS (Source: DGMET).
