# Oman Transport Safety Bureau (OTSB)

## Final Report

OTSB Case File No: AIFN-002/05/2025

### Runway Incursion (RI) between Two Oman Aviation Academy (OAA) Aircraft - Diamond DA40 NG A4O-OAI and Diamond DA40 NG A4O-OAG At Sohar (OOSH) International Airport, Sultanate of Oman.

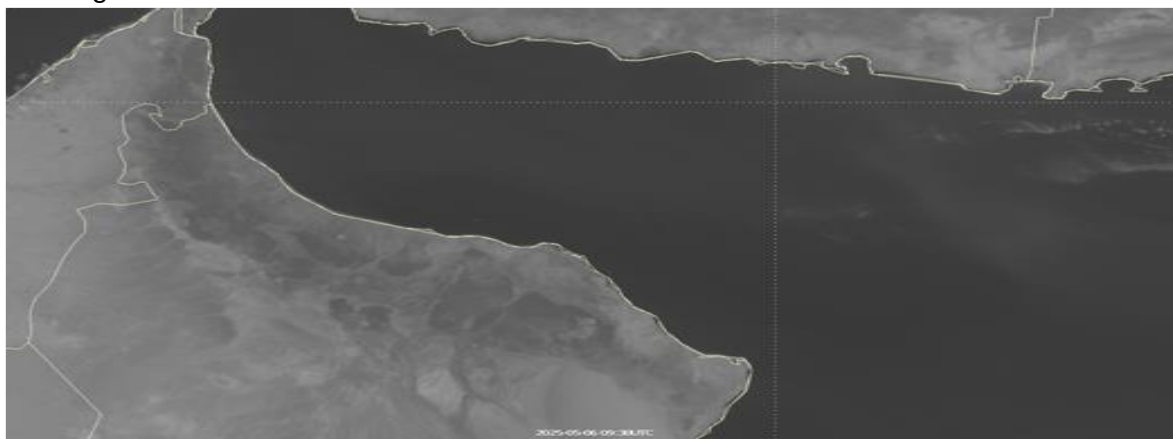
1.7.5 Conclusion: The region remained under the influence of stable weather, with clear skies, light to moderate winds, and no significant weather hazards present therefore no aerodrome warnings or SIGMETs were issued.

Figure - 4 showing satellite image at 09:30Z on 06<sup>th</sup> May 2025 (Source: DGMET)

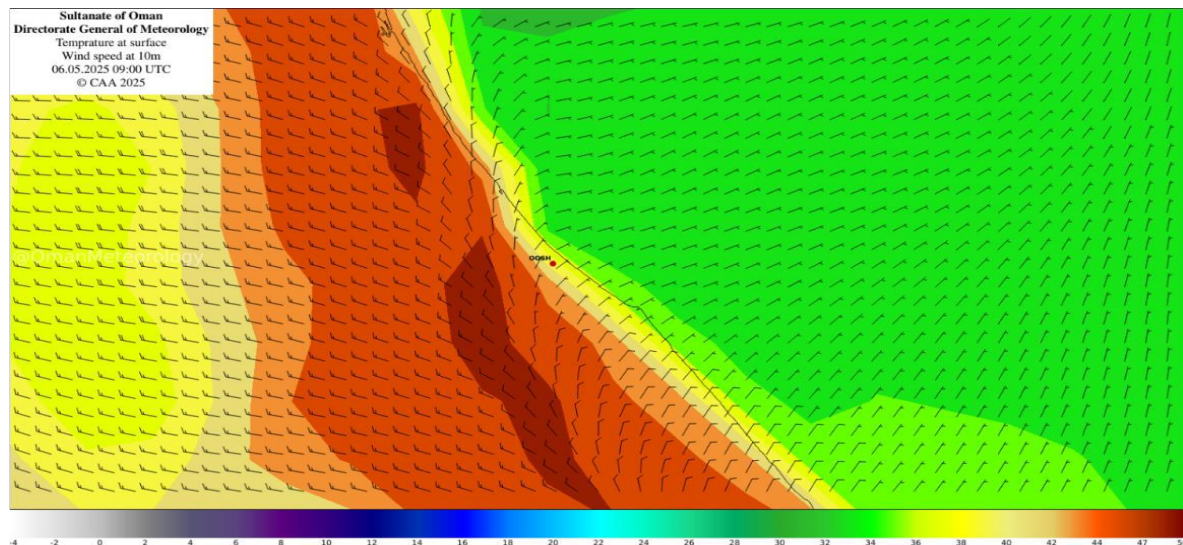
- At 08:50 UTC, surface winds were reported at 06 knots from 020°, indicating a light northeasterly breeze, temperature: 45°C and QNH: 1002 hPa.
- By 09:50 UTC, wind speeds increased slightly to 10 knots from 280°, showing a shift to a moderate westerly direction with increase in temperature to 46°C, QNH: 1002 hPa.
- Visibility remains good, and no precipitation or significant weather phenomena were observed during the reporting period.

Figure - 5 showing surface temperature and 10m wind data at 09:00 UTC on 6<sup>th</sup> May 2025  
(Source: DGMET)
